UNDERWATER FACILITIES
INSPECTION AND ASSESSMENT
AT MAGNETIC SILENCING FACILITY
NAVAL SUBMARINE BASE
TRIDENT SUPPORT SITE
BANGOR, Washington
FPO-1-80 (13)

UNDERWATER FACILITIES INSPECTIONS & ASSESSMENTS

OCEAN ENGINEERING AND CONSTRUCTION PROJECT OFFICE
CHESAPEAKE DIVISION
NAVAL FACILITIES ENGINEERING COMMAND
WASHINGTON, D.C. 20374

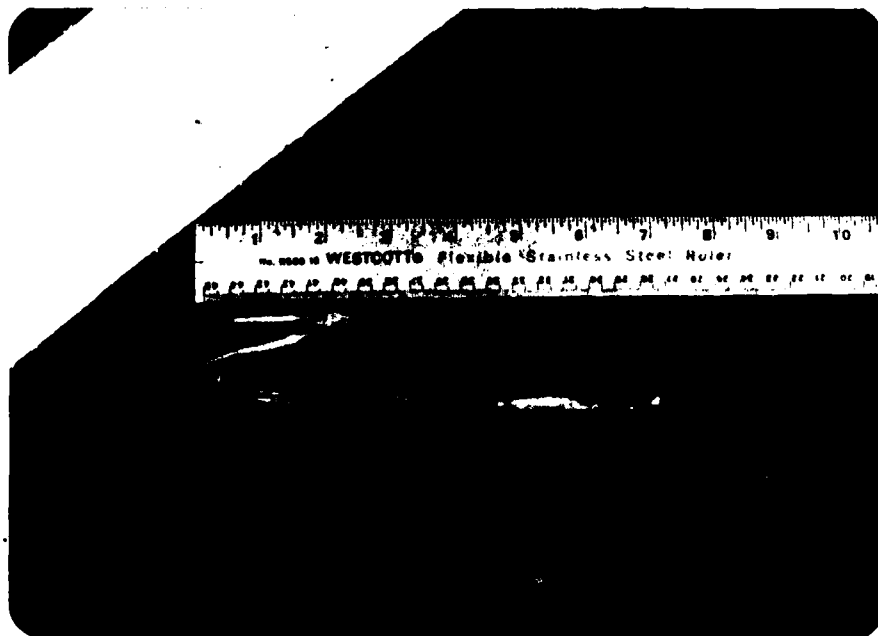
PHOTOGRAPH 18

Live Bankia taken from damaged pile 77W-3N. Bankia measured 7 inches with a diameter of $\frac{1}{2}$ ".

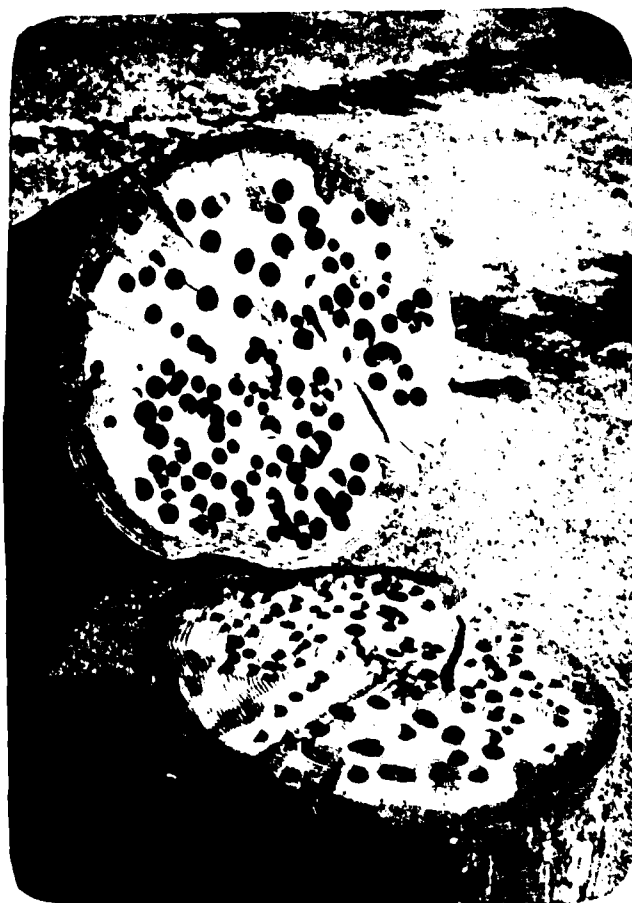
PHOTOGRAPH 24

Bankia damage in piling can only be determined by underwater inspection, with many attendant difficulties. If the Bankia are alive and the siphons are extended, recognition is not too difficult. If the siphons are retracted or the Bankia are dead, detection of the burrow openings is not easy. In many instances, fouling must be scrubbed off the piling in order to facilitate an inspection. If visibility is limited, as frequently occurs in industrial locations, visual inspection is hopeless. Even if teredine entry holes are observed, an evaluation of internal damage, by purely visual means, is not possible. (See photographs 23,24).

Same pile cut to show extensive internal teredine damage.

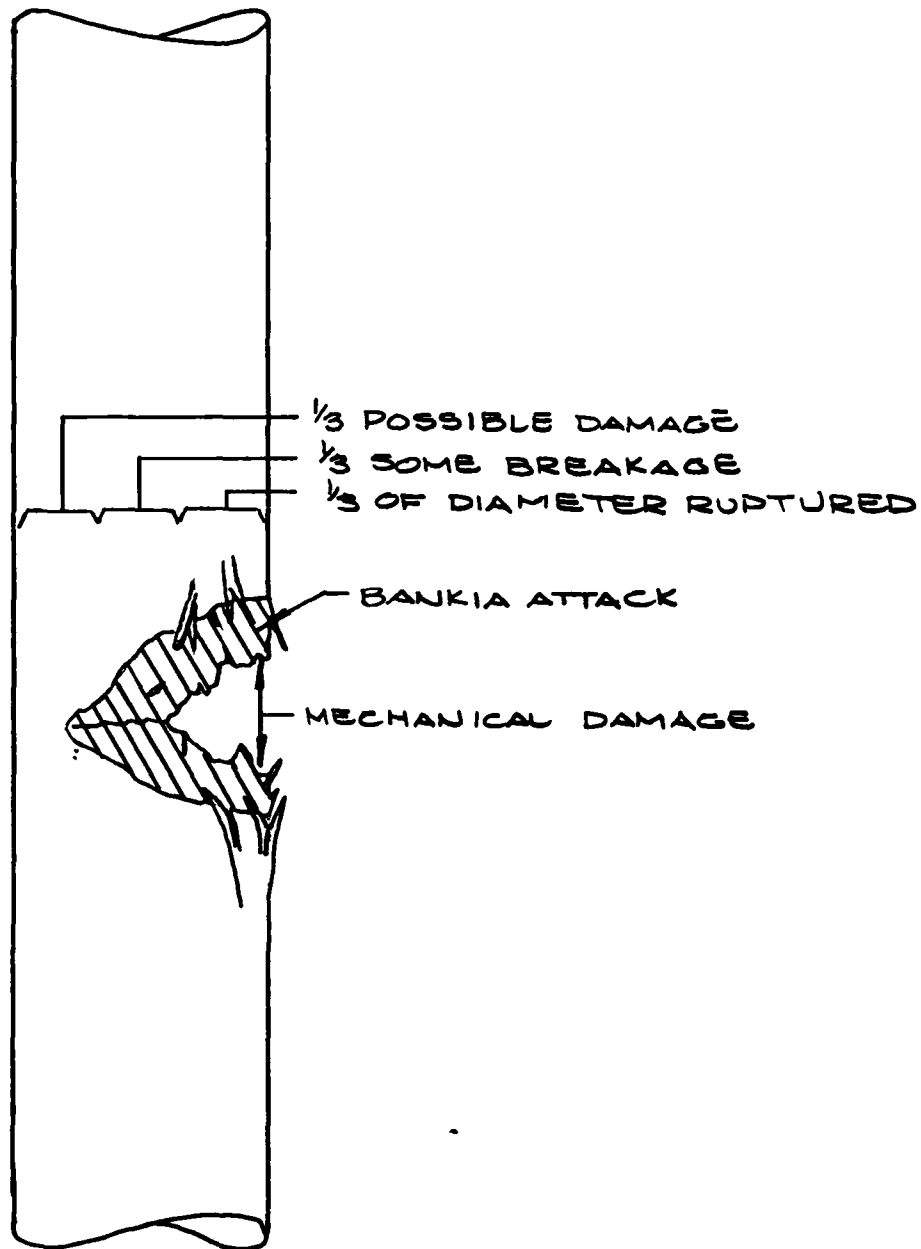
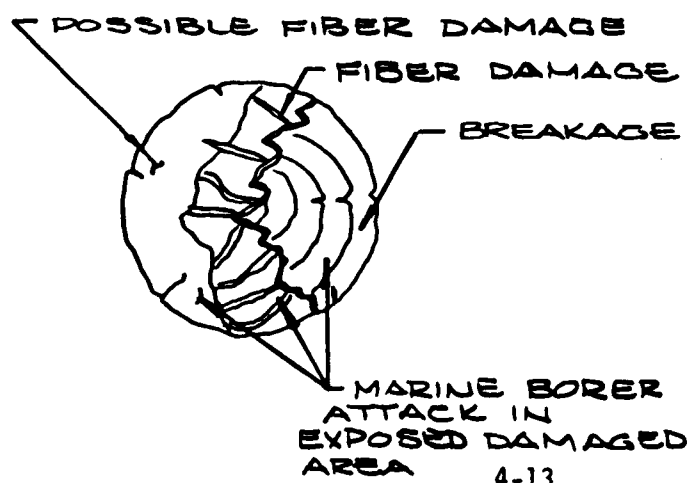
DAMAGE DETAIL

WEST PIER
BENT 77, PILE 35
6 OCT, 1980

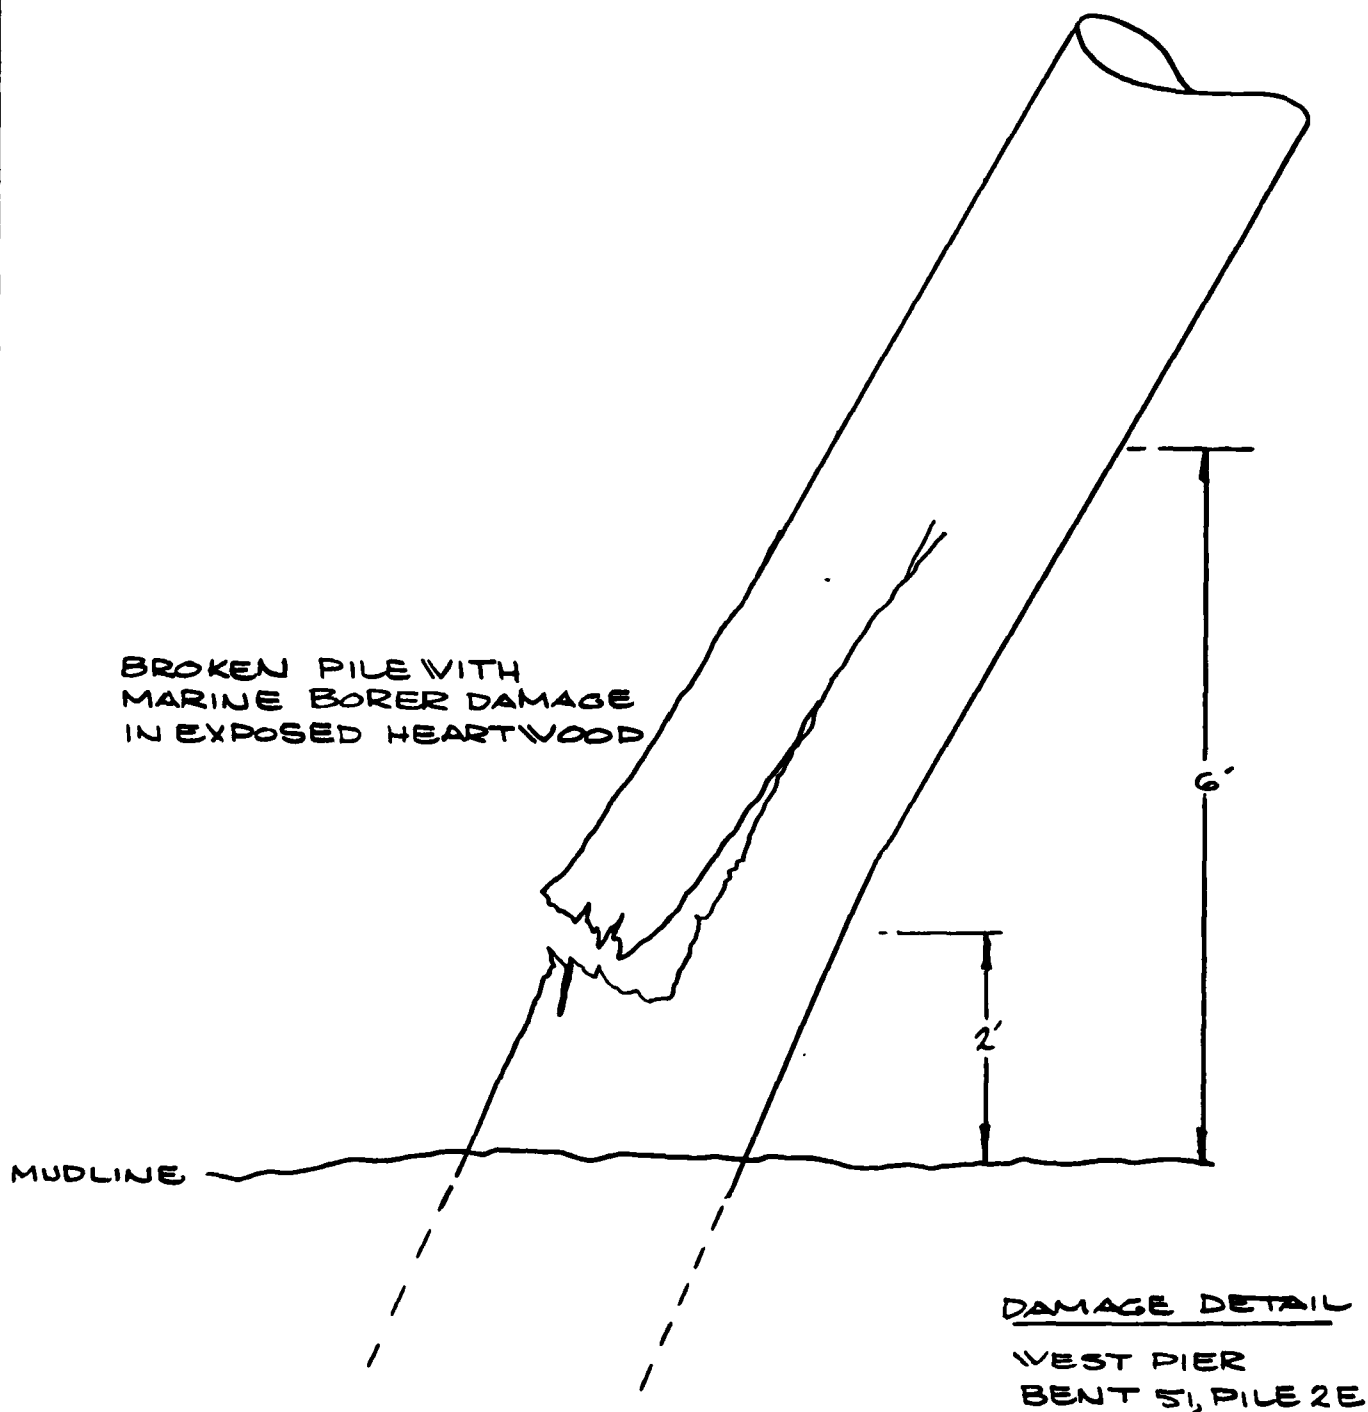
FIGURE 8

Pile 51W-3E is broken at the mudline with marine borer (Bankia) attack at the area of rupture. This pile may have hit a rock below the mudline which resulted in "brooming" at the mudline during driving (see Figure 8).

the complete destruction of the pile within one or two years. Since physical damage sustained during the driving of a pile often occurs at the mudline, underwater inspection is necessary for positive identification of all piling subjected to this type of damage. (Note pile 51W-2E.)

Removal of the damaged pile is recommended if driving of a replacement pile is anticipated. Removal of derelict piles facilitates the placing of replacement piles, facilitates future inspections and removes an immediate source of marine-borer infestation.
